# STEAMLINE DEFICIENCIES

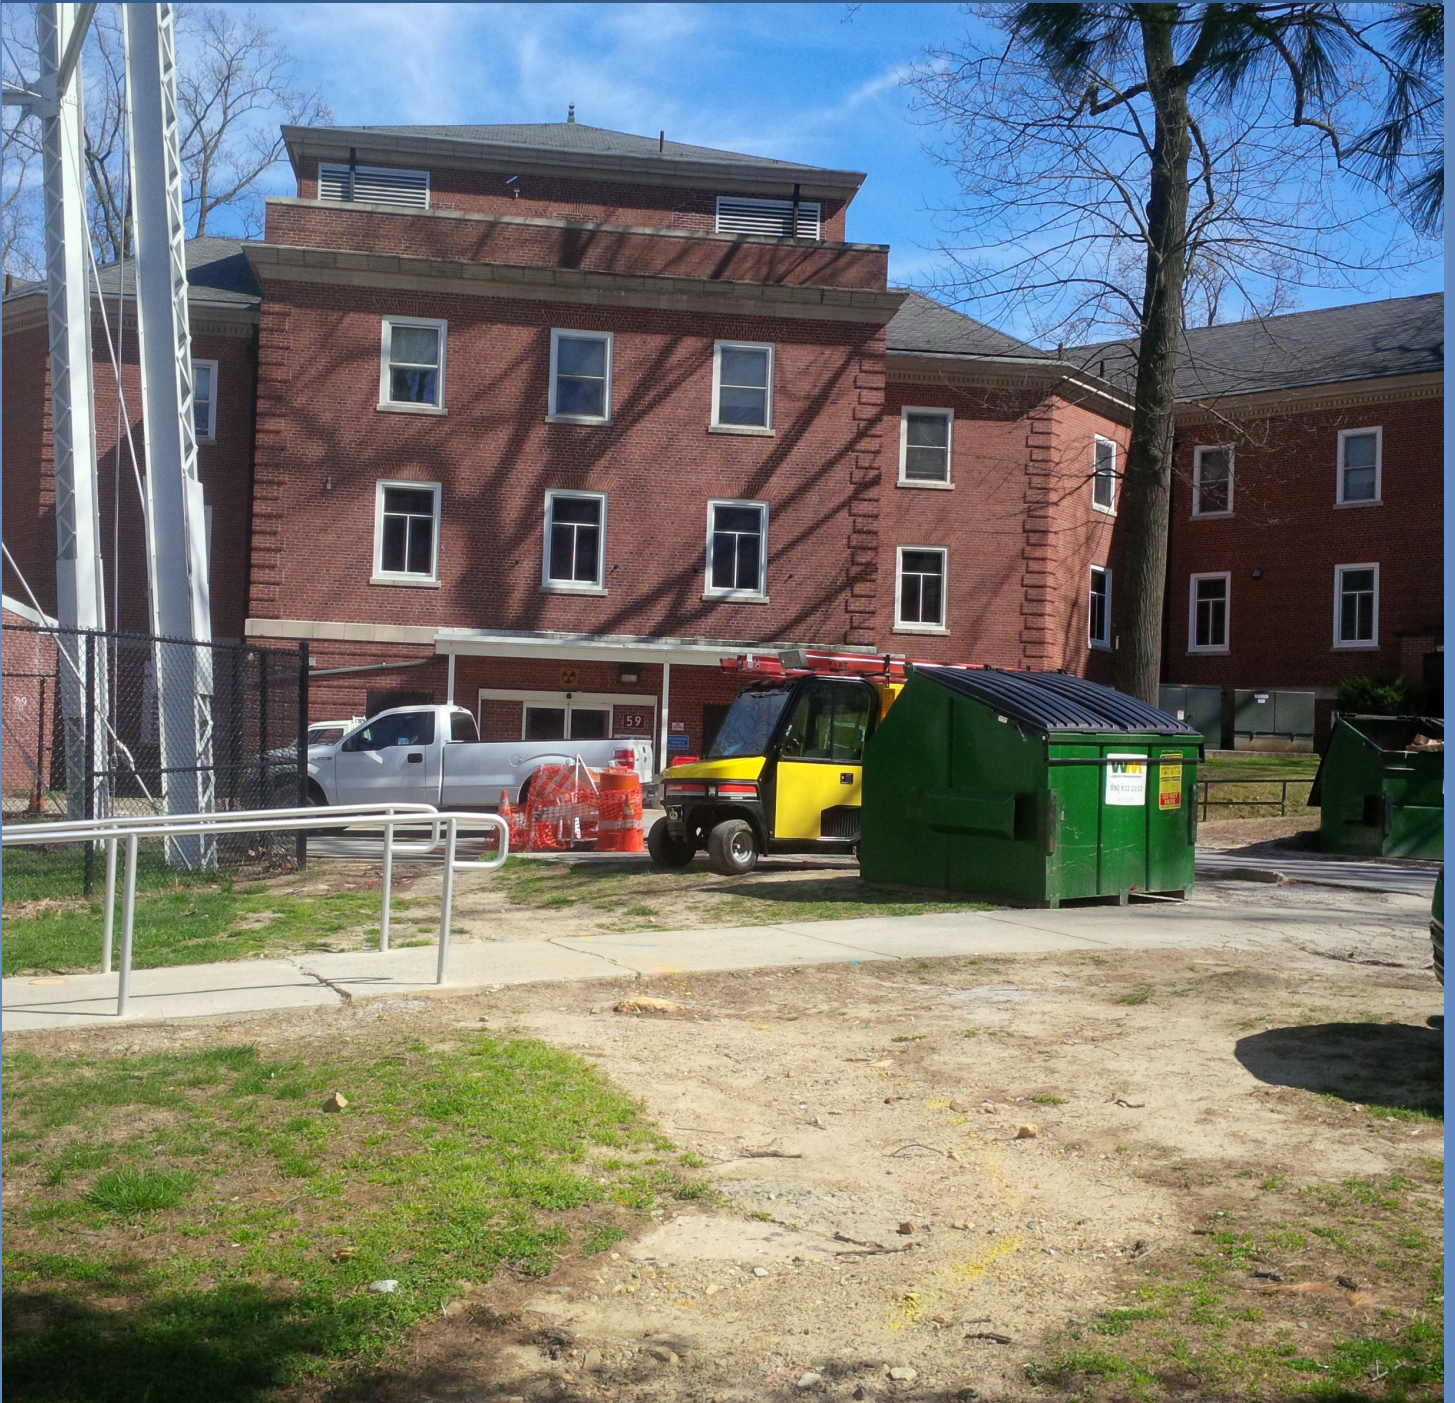
FIGURE 1

***STEAM LINE PATH IN FRONT OF BUILDING 59***

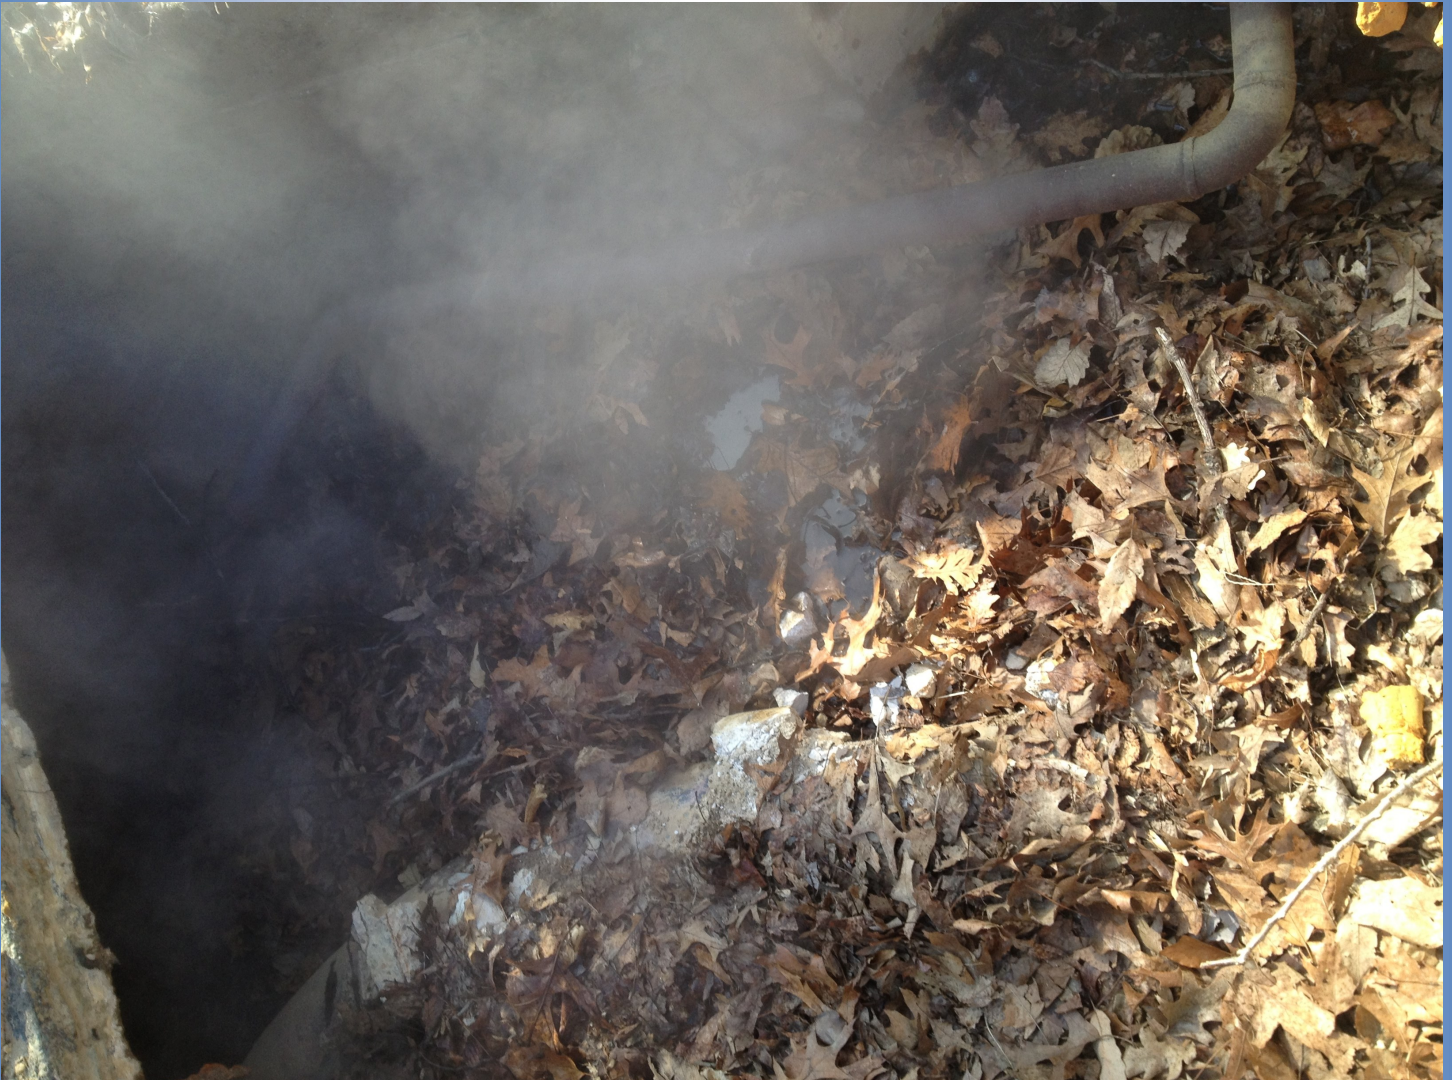
FIGURE 2

***STEAM LINE IN FRONT OF BUILDING 59 IN THE HOLE  
BLOCKED OF BY CONSTRUCTION FENCE AND TRAFFIC CONES***

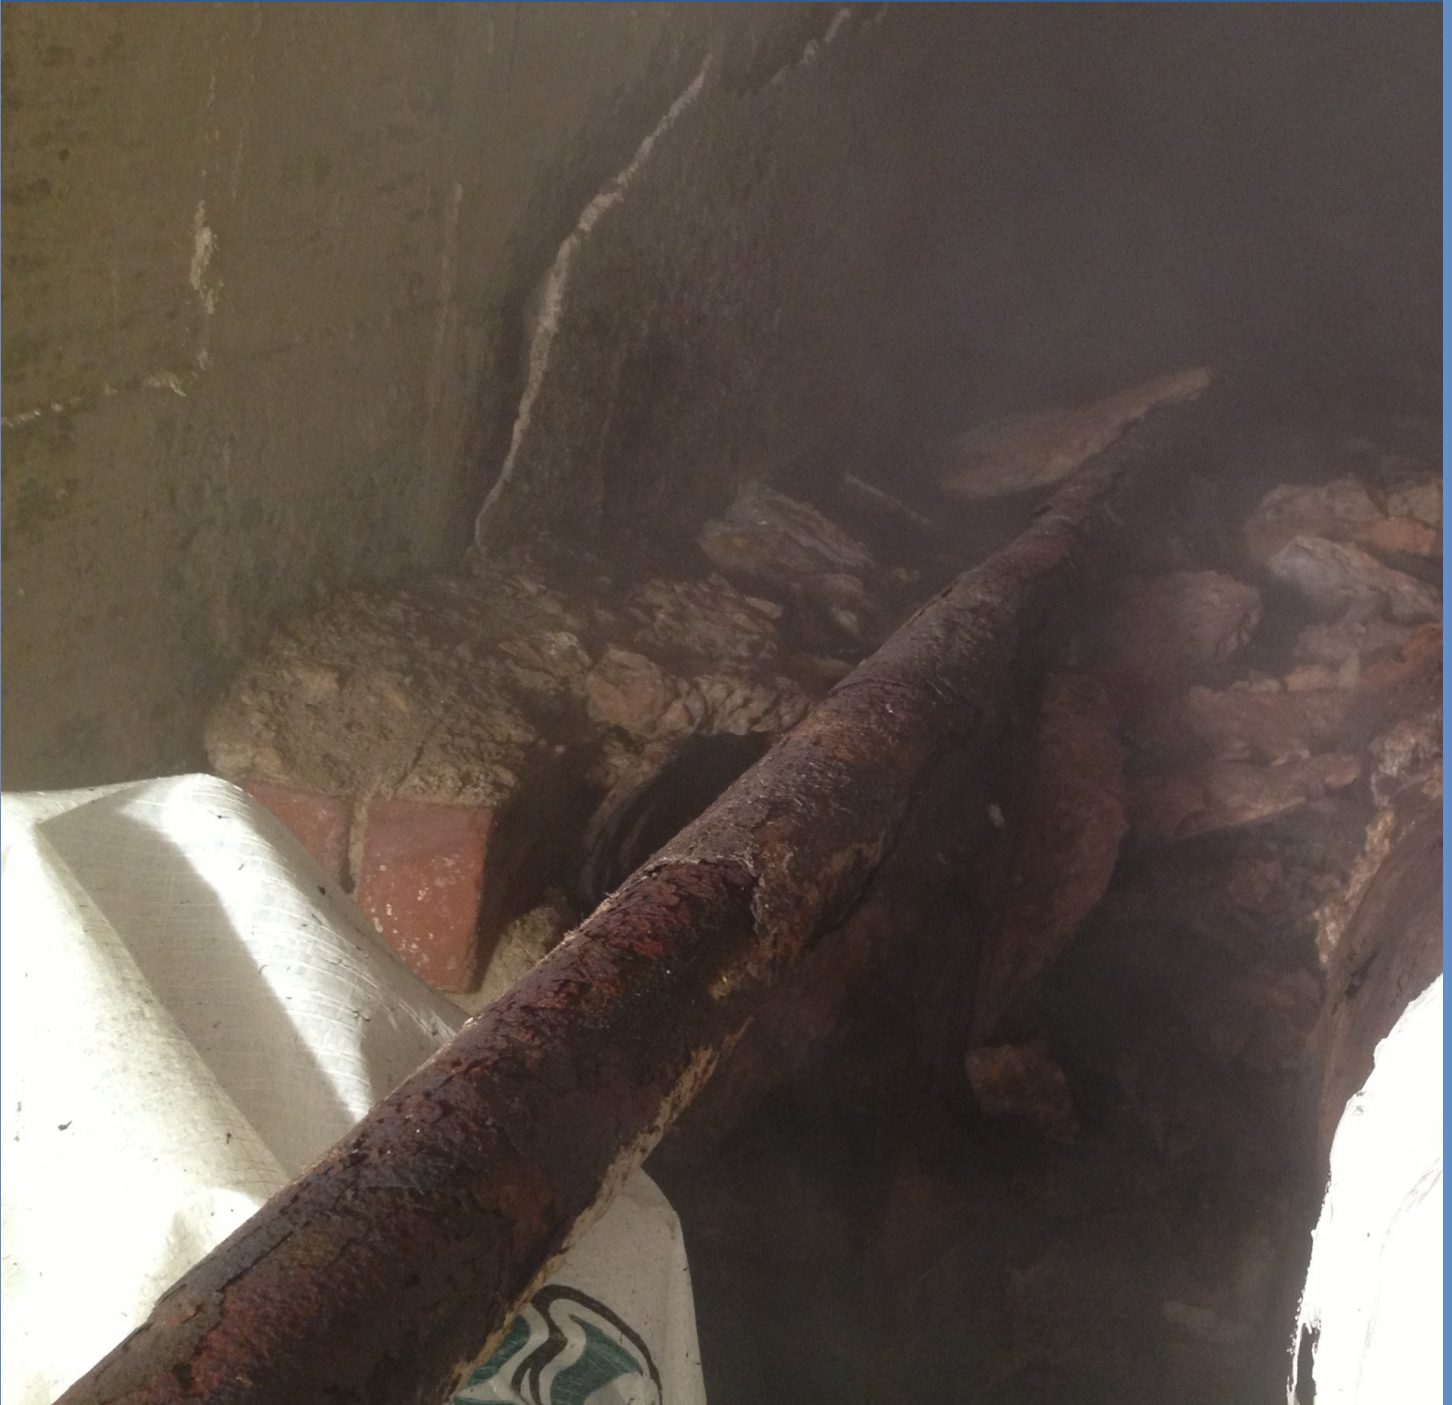
FIGURE 3

***STEAM LINE IN FRONT OF BUILDING 59 RUNING DOWN  
TOWARD THE STREET***

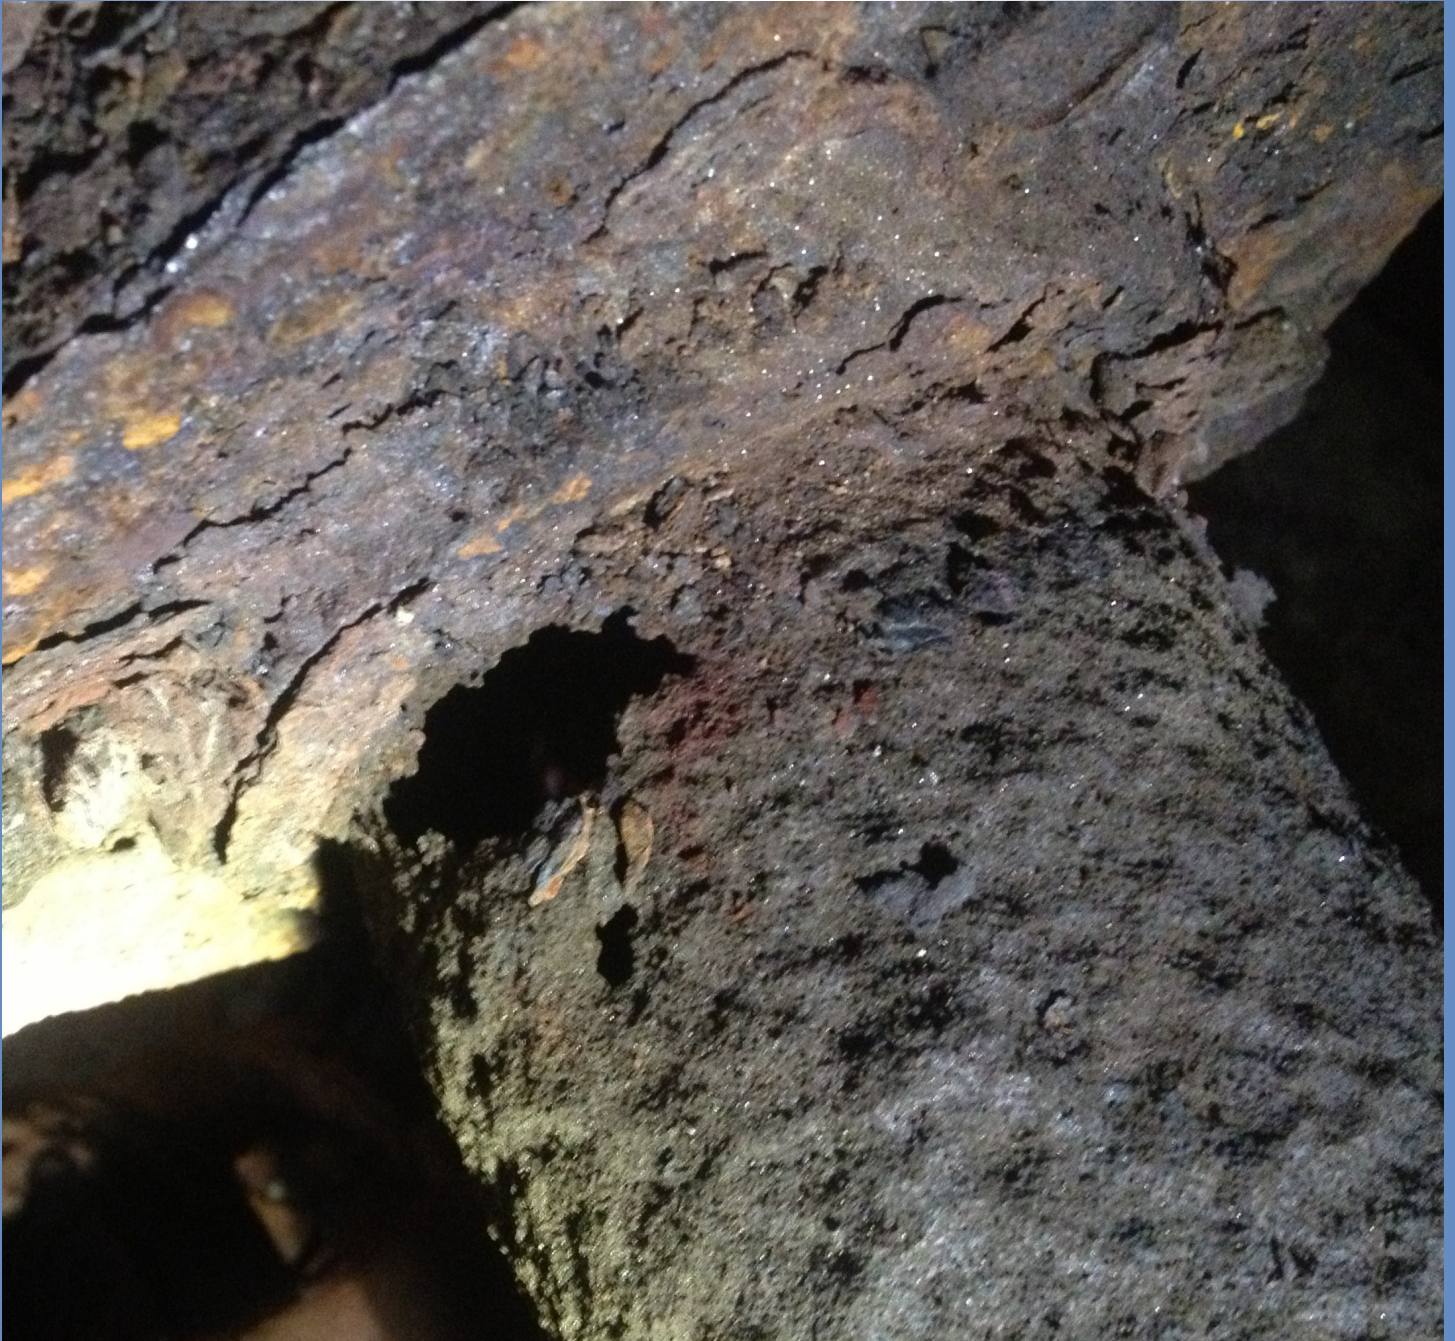
FIGURE 4

***T IN STEAM LINE IN FRONT OF BUILDING 59***

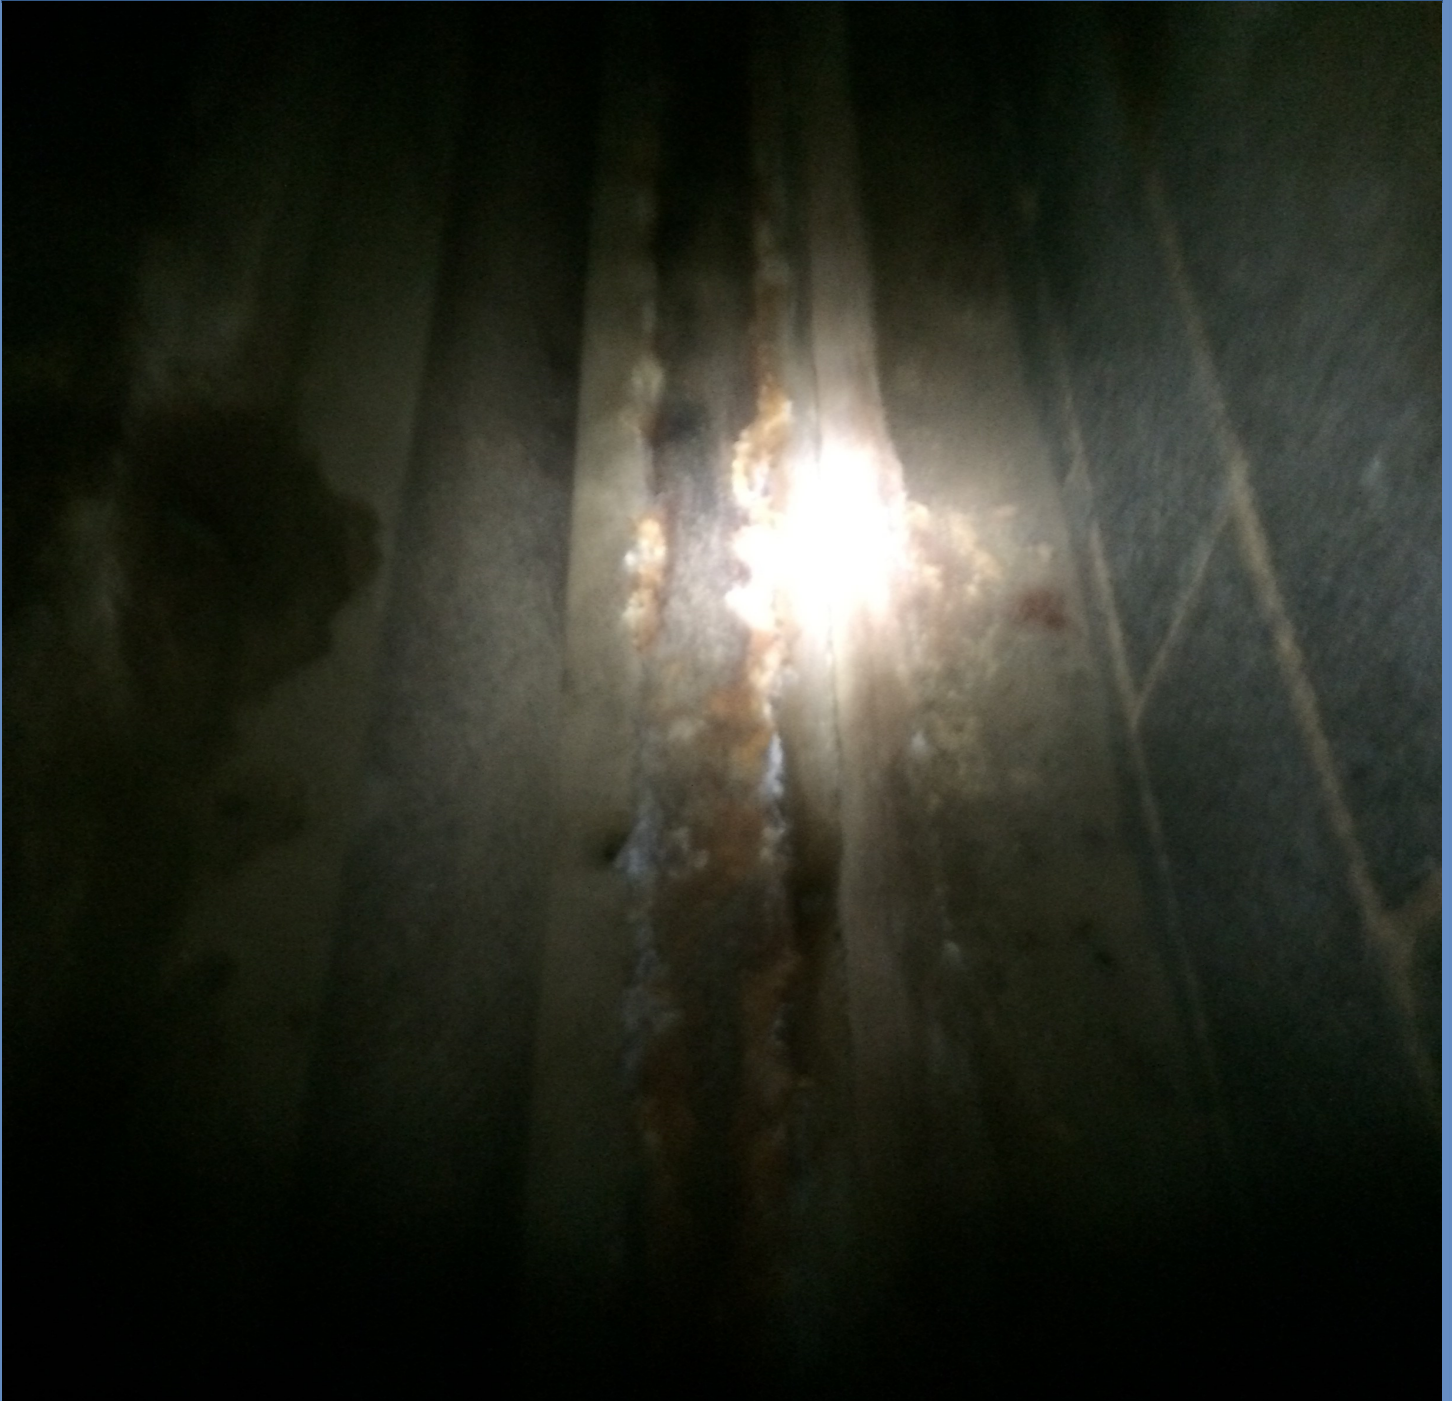
FIGURE 5

***STEAM LINE TRENCH UNDER MANHOLE BY BUILDING 15***

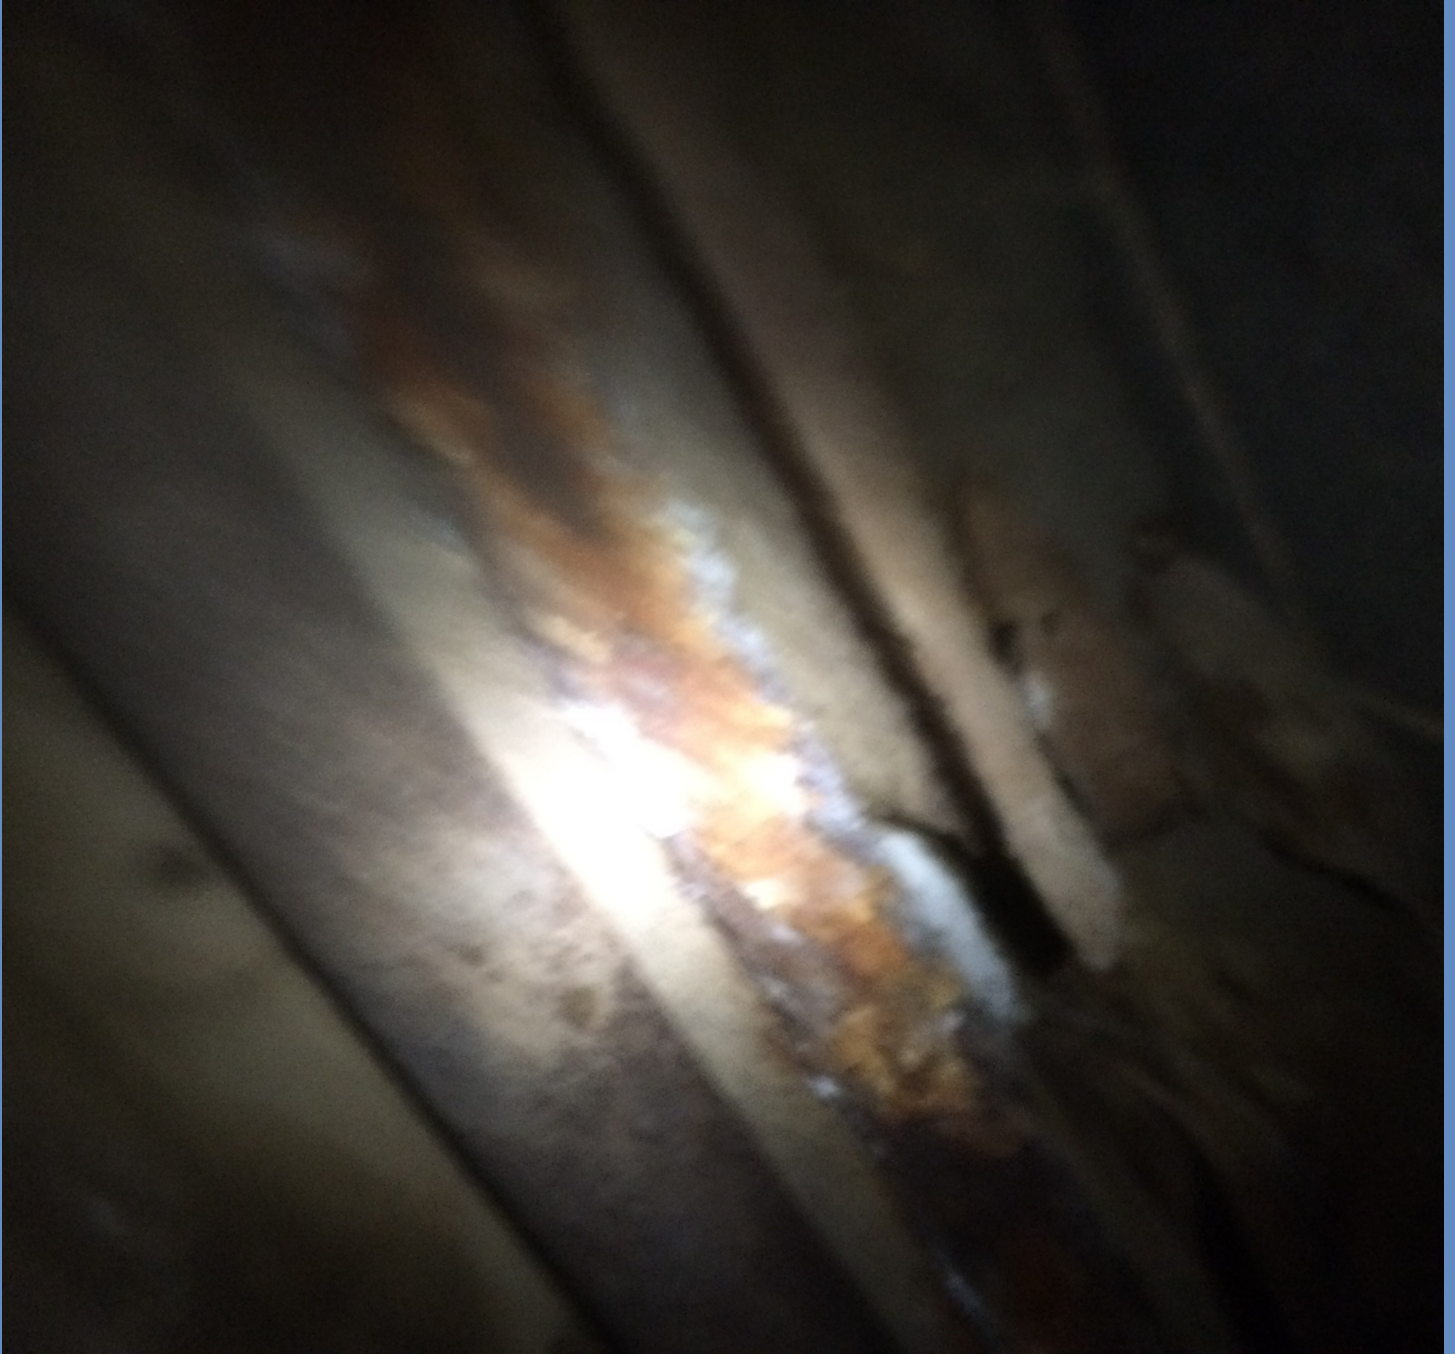
FIGURE 6

***CORRODED SECTION OF PIPE UNDER MANHOLE BY BUILDING  
15***

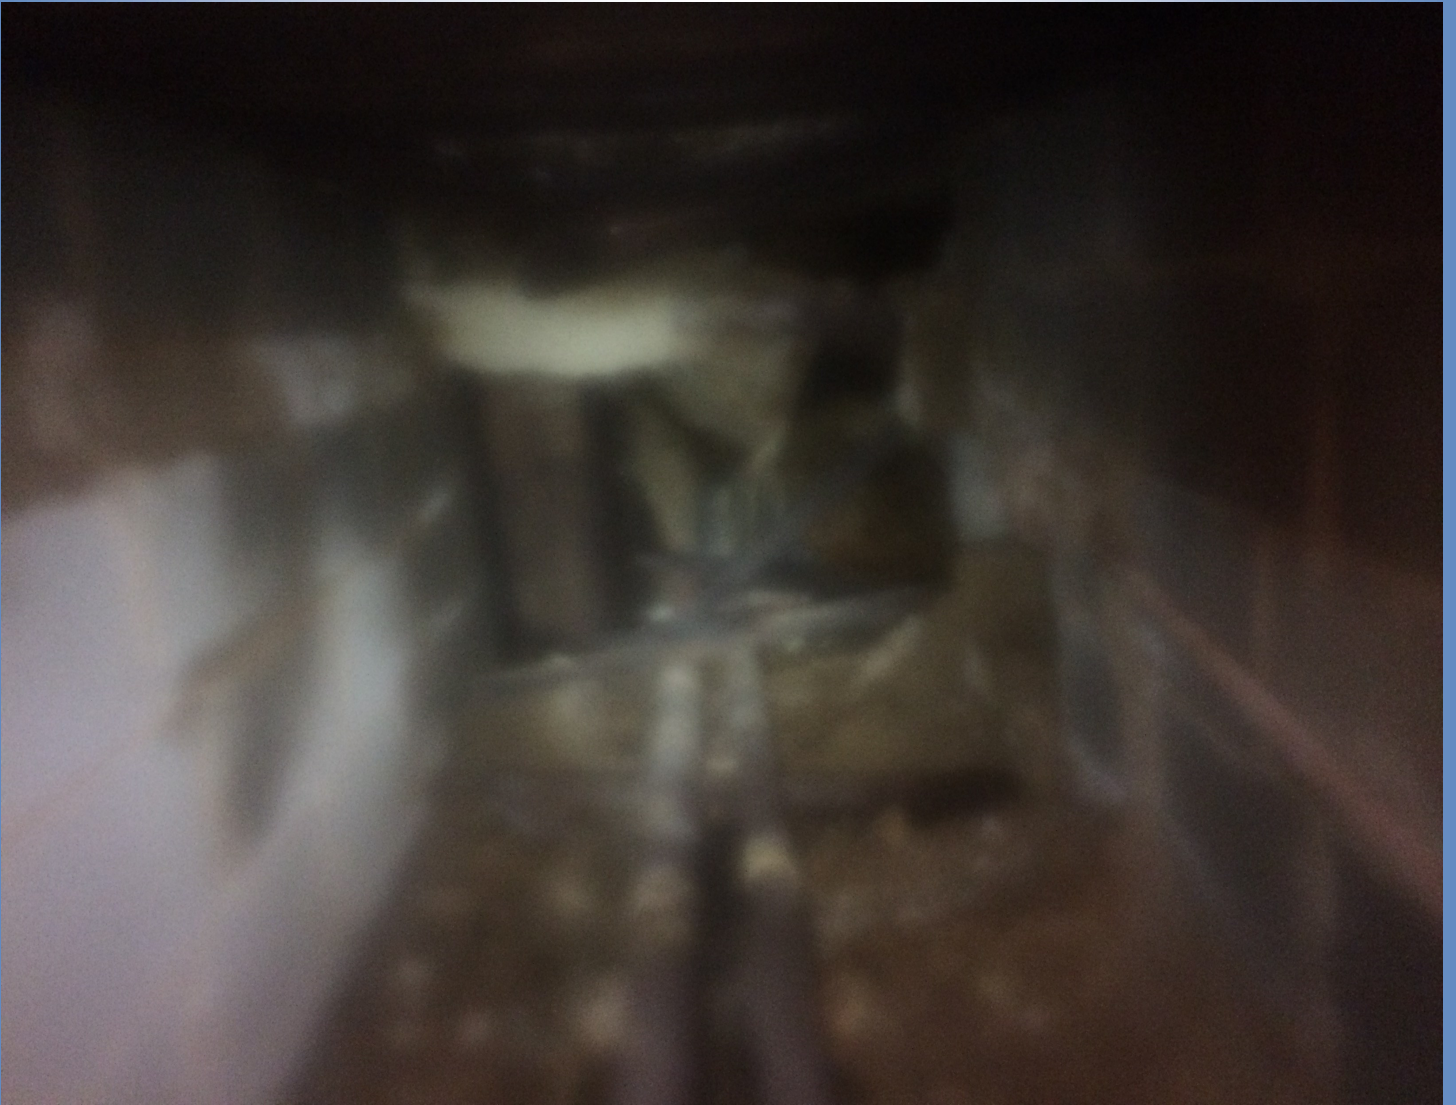
FIGURE 7

***STEAM LINE RUNNING DOWN INTO BUILDING 15***

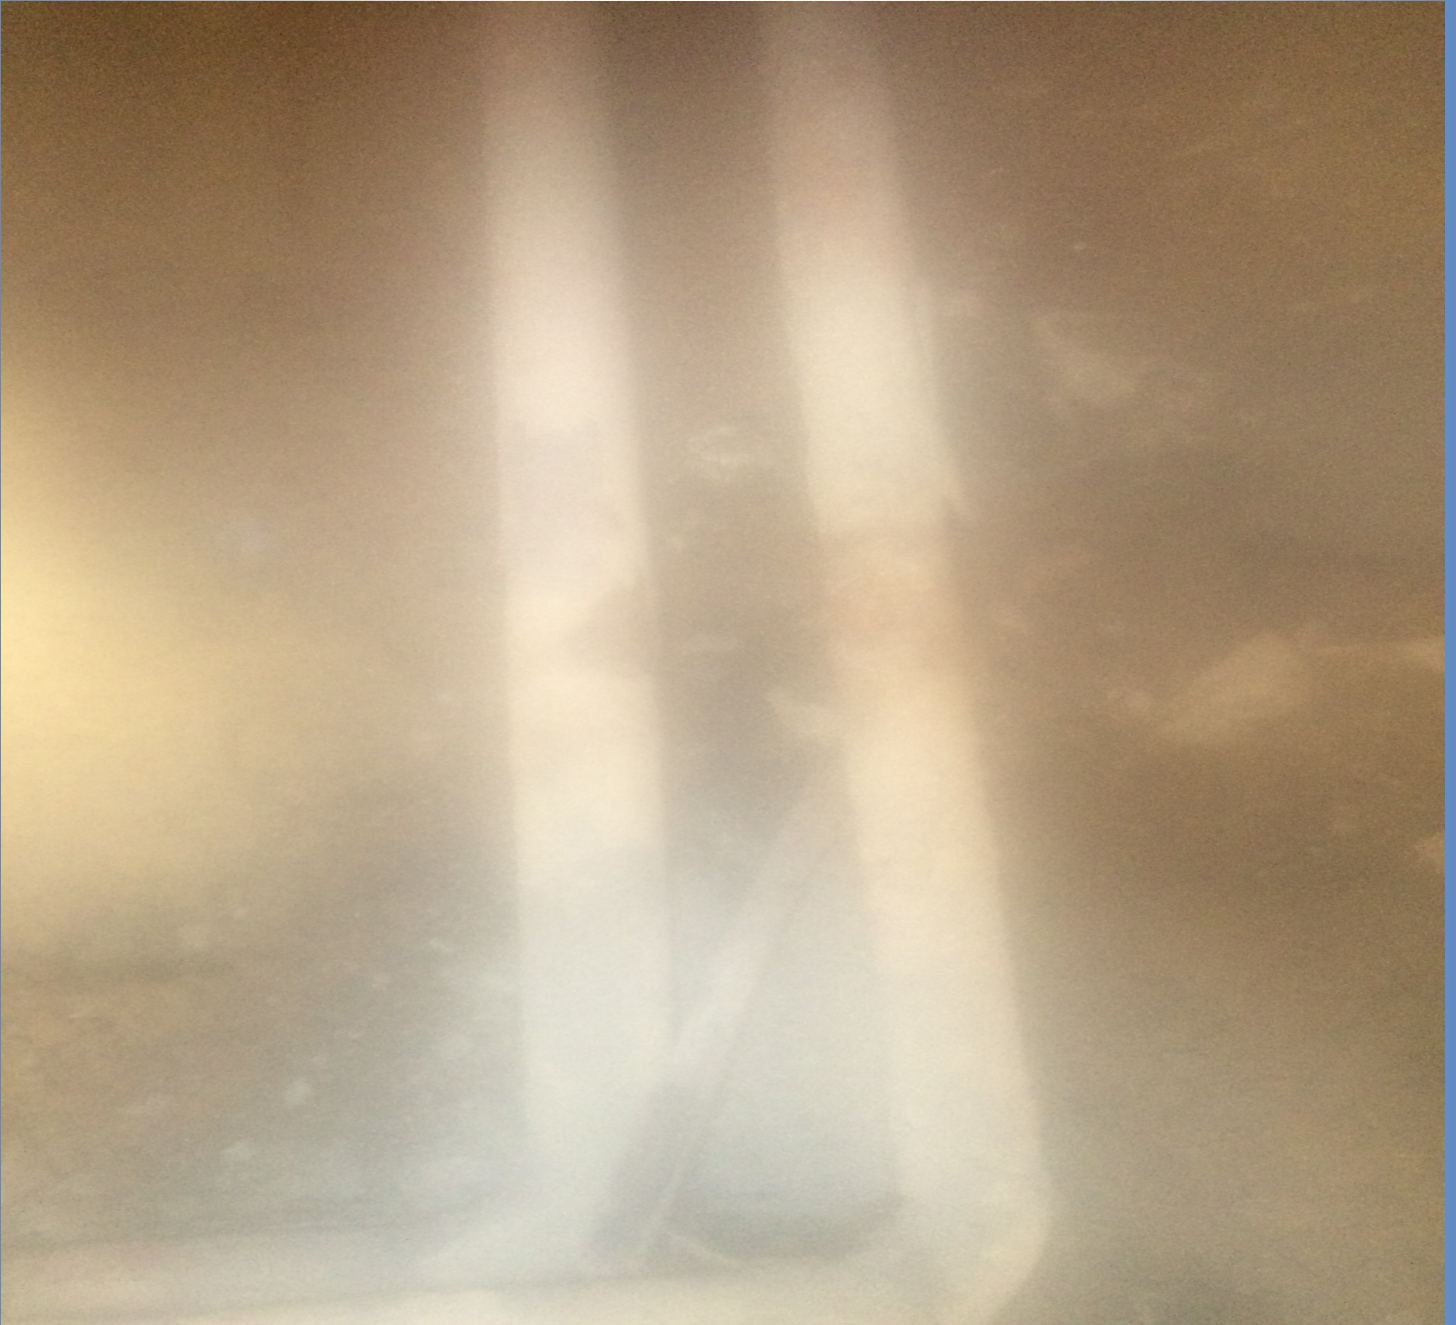
FIGURE 8

***STEAM LINE TURNING INTO CONCRETE VAULT GOING FROM  
BUILDING 15 TO BUILDING 70***

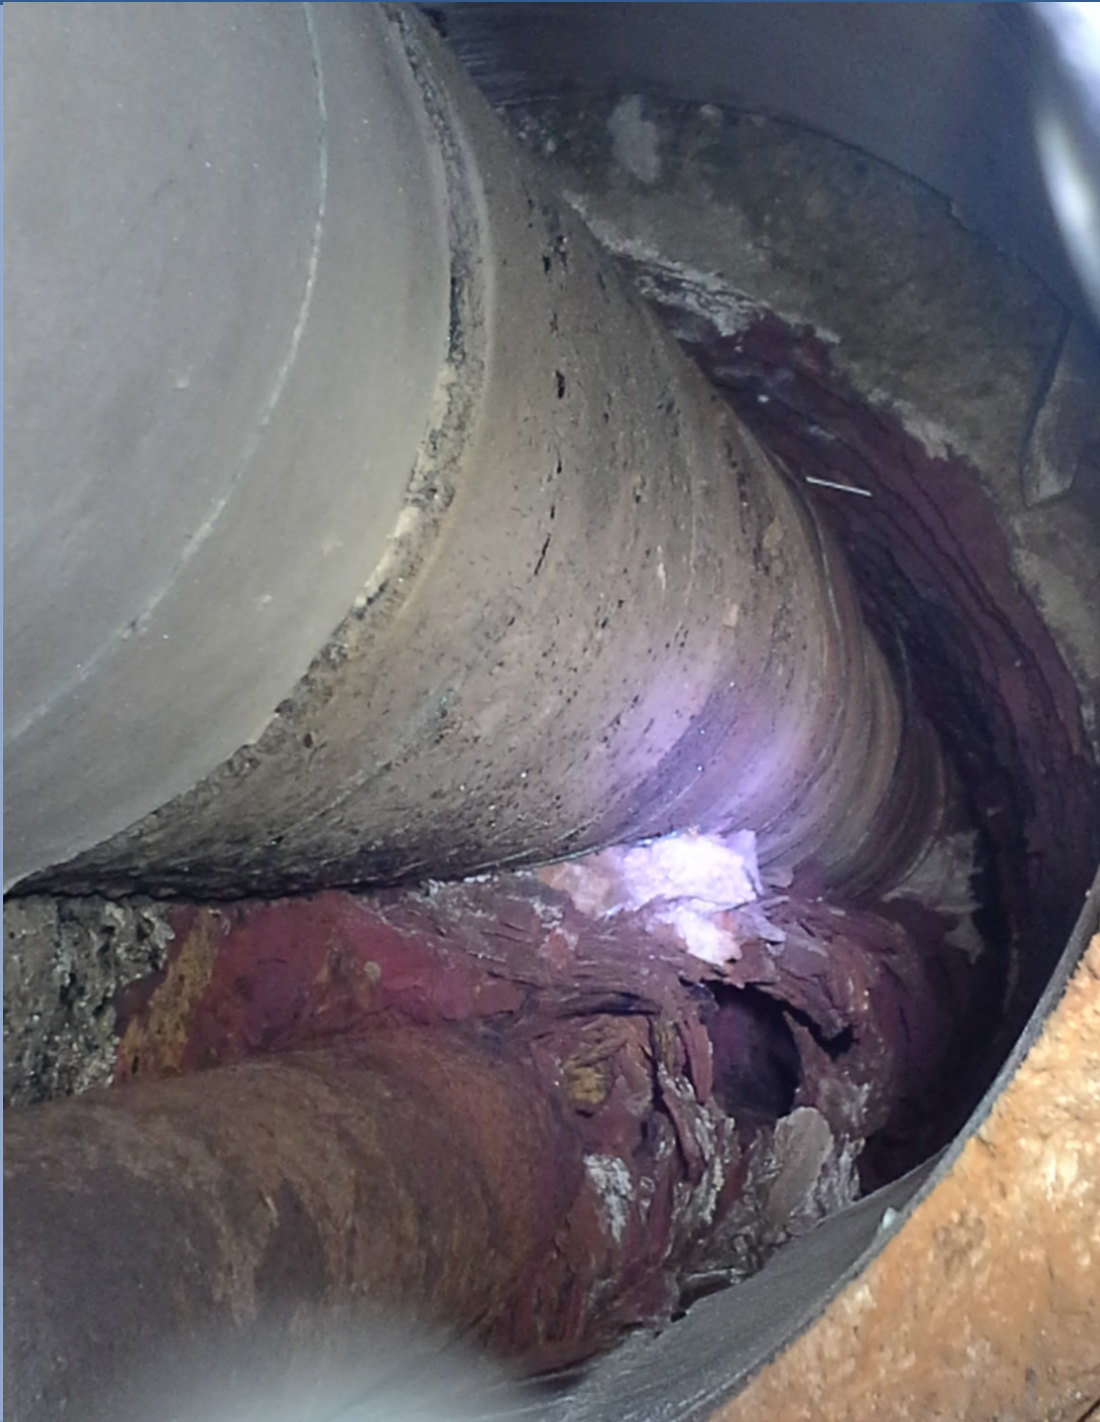
FIGURE 9

***STEAM LINE ENTERING CONCRETE VAULT GOING FROM  
BUILDING 15 TO BUILDING 70***

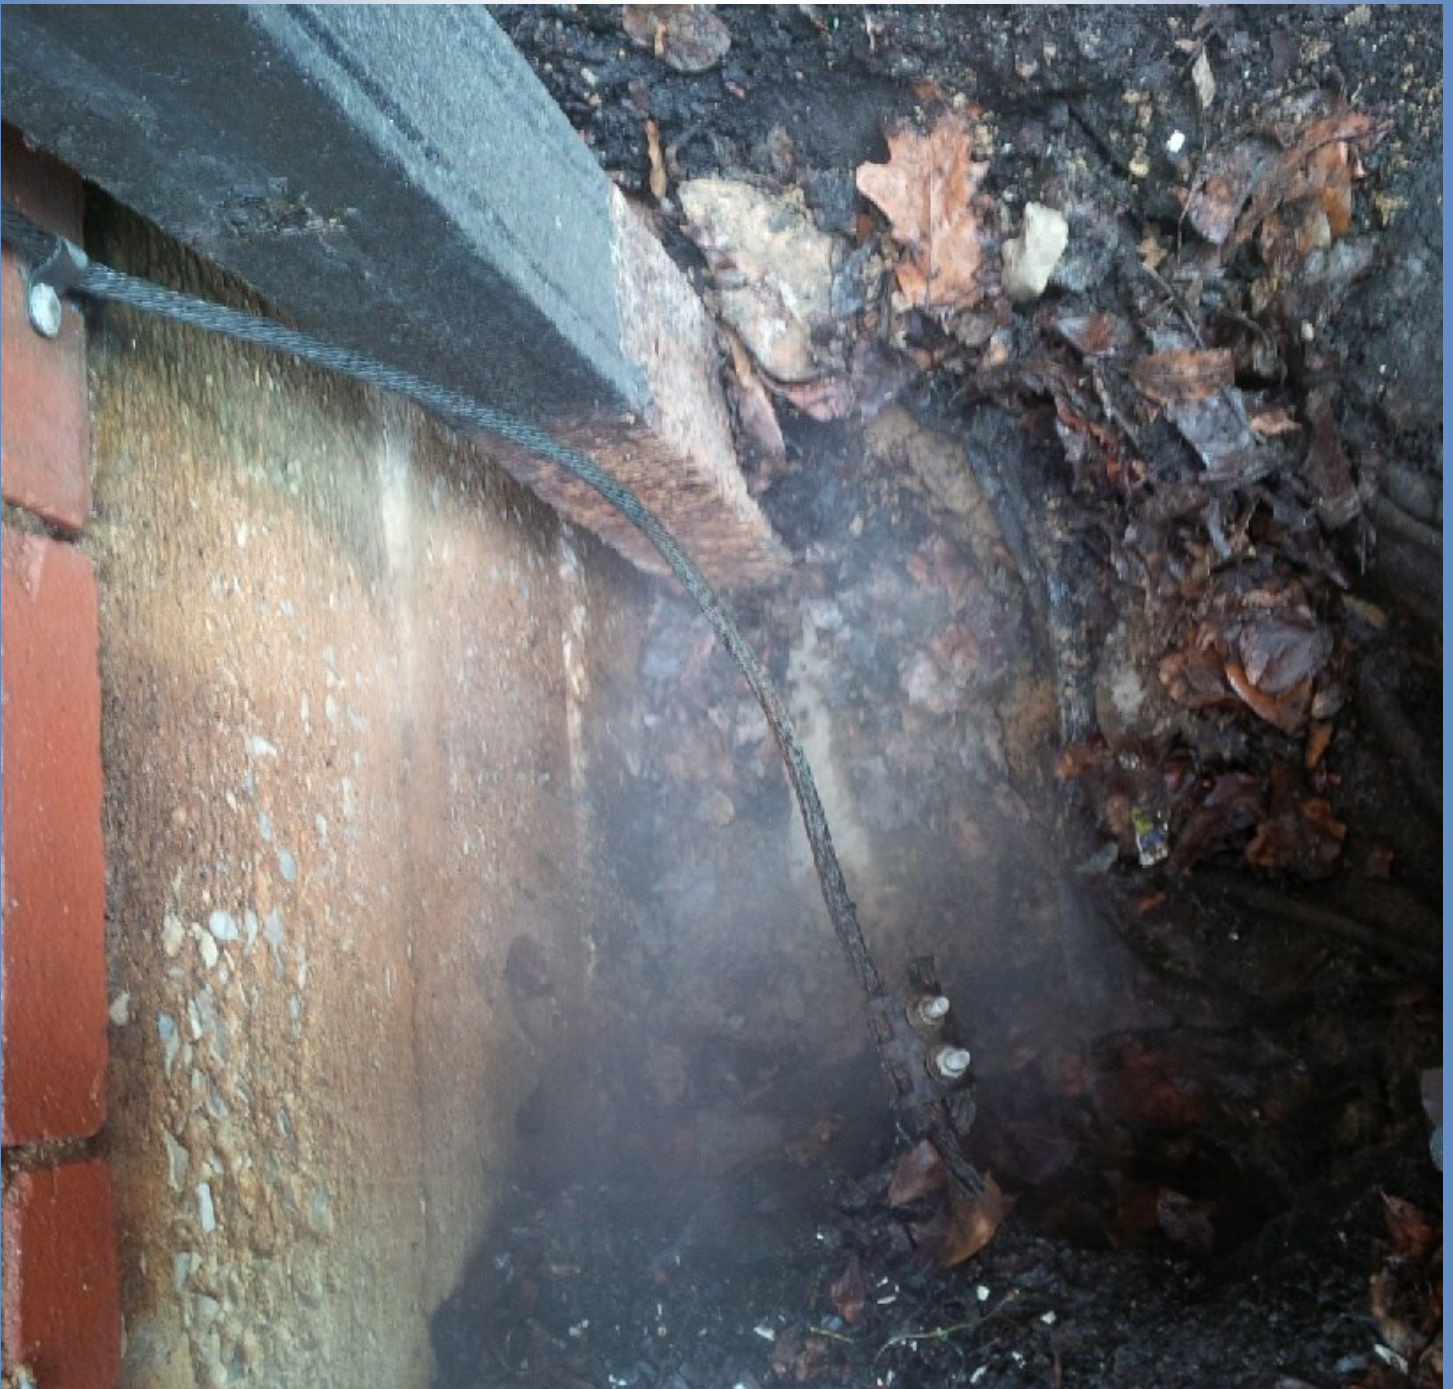
FIGURE 11

***STEAM VAULT ON THE OUTSIDE OF BUILDING 18 COLLAPSING***

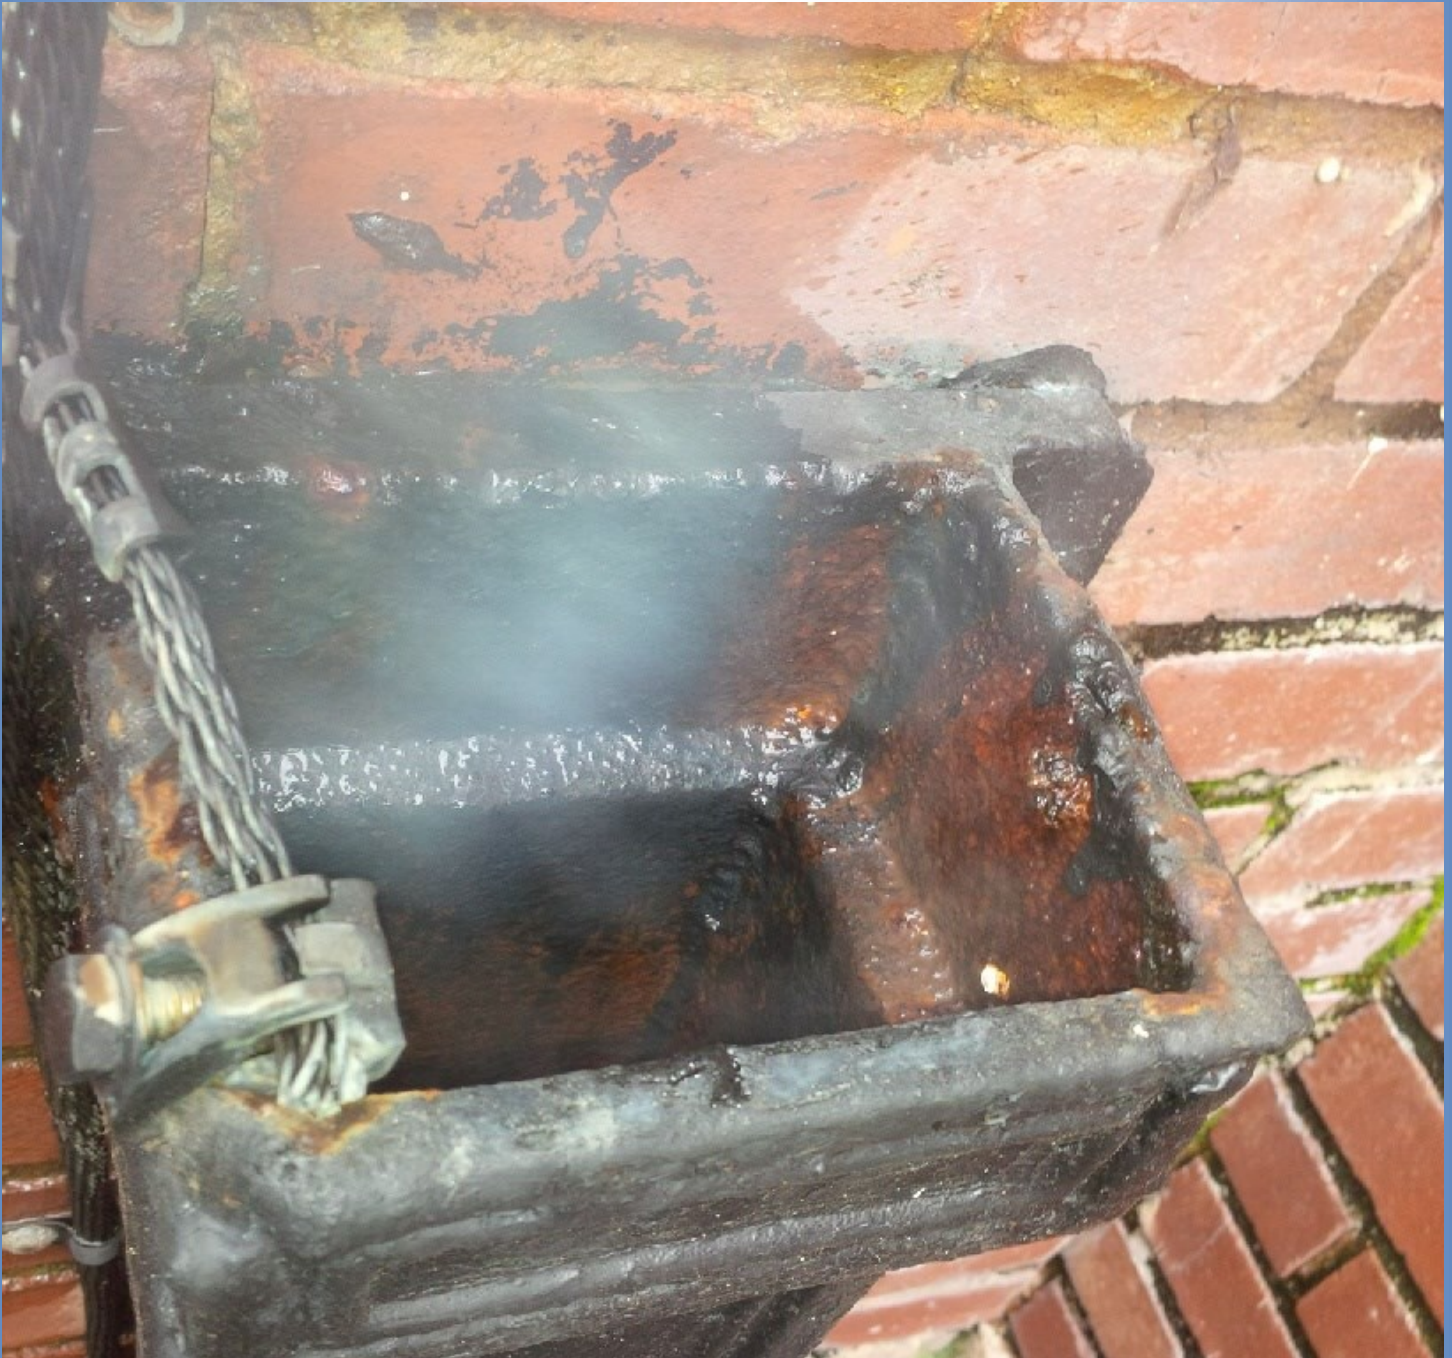
FIGURE 11

***STEAM POURING OUT FROM DOWNSPOUT BOOT DUE TO  
COLLAPSEING VAULT AT BUILDING 18***

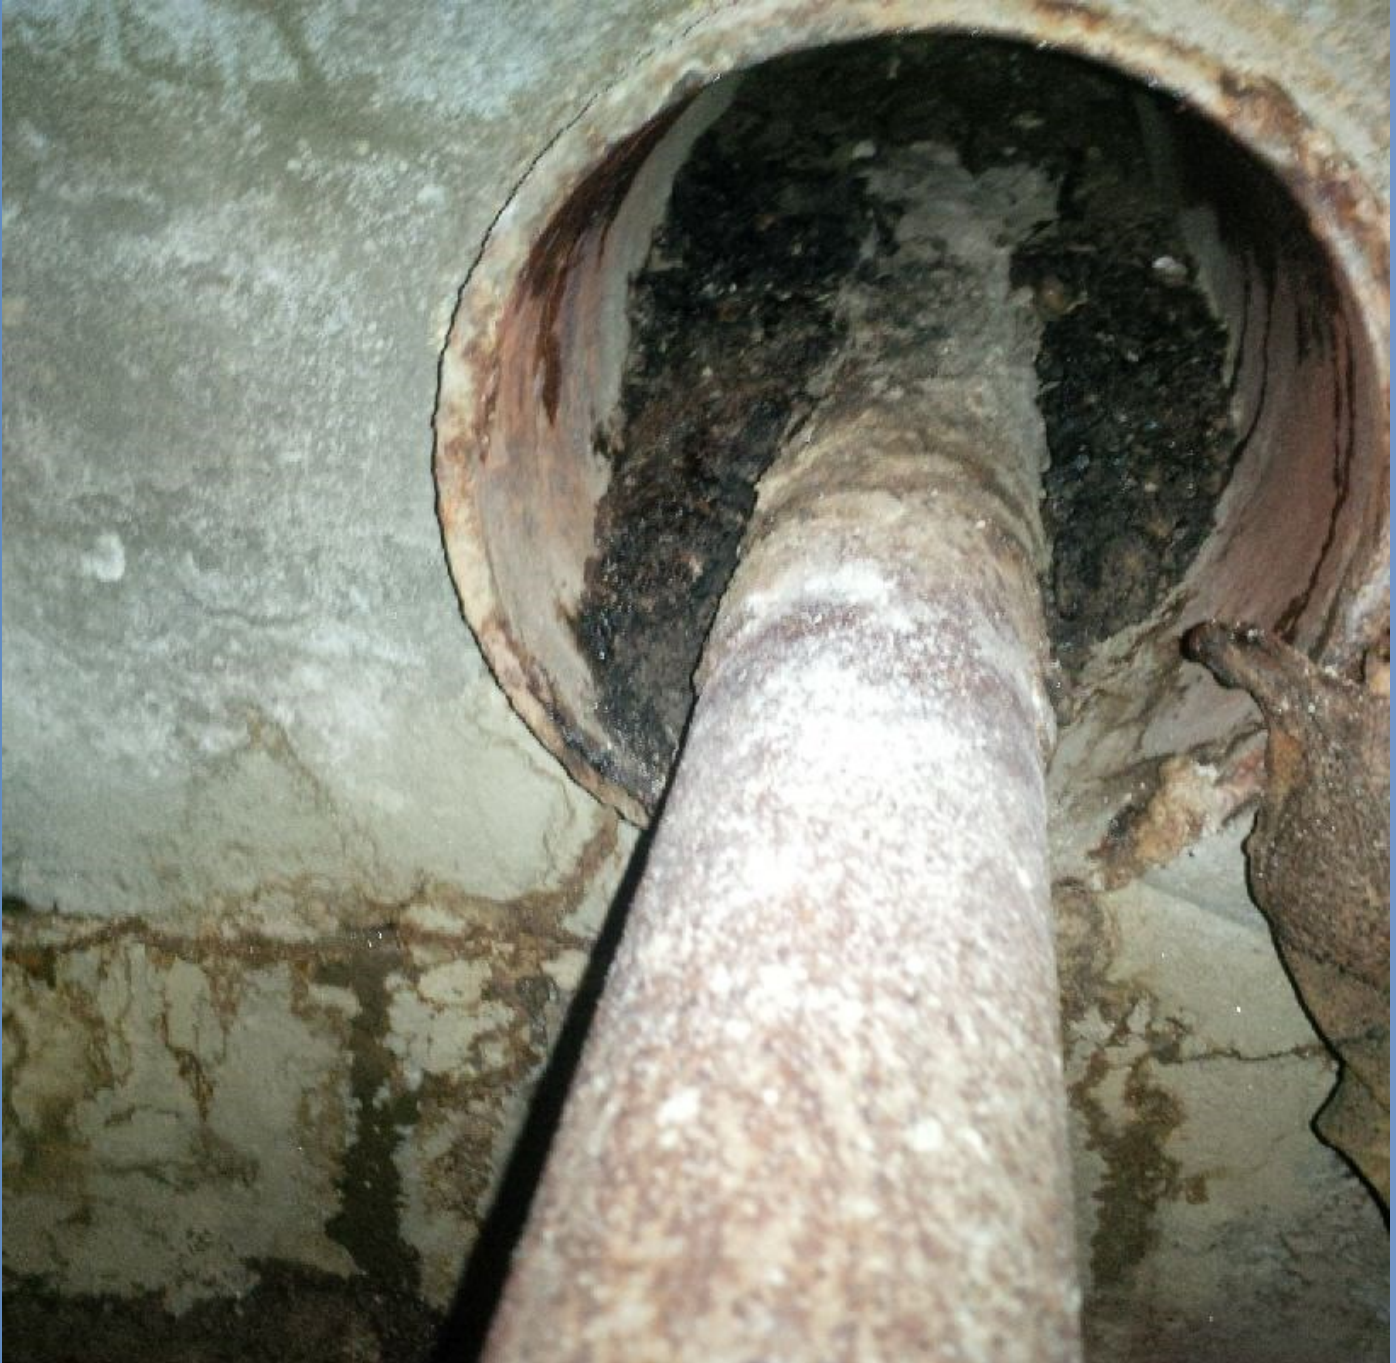
FIGURE 11

***STEAMLINE FROM THE INSIDE OF BUILDING 18***
